List of Scenarios Outline (1)

- Leading the list are examples of Byzantine failures because of the very widespread “that can’t happen” disbelief in these failures and the fact that there are known solutions
- Introduction to the Byzantine Generals Problem
 - Definitions of Fault, Failure, and Error
 - Byzantine failure definitions and background
- Examples of actual occurrences
 - Space shuttle mission STS-124
 - Space shuttle data bus standing wave
 - Mid-value select
 - Command / Monitor wrap-back
 - Time-Triggered Protocol (TTP/C) heavy ion fault injection
 - Multi-Microprocessor Flight Control System (M²FCS)
 - Potential grounding of an entire aircraft fleet
 - A pushbutton input to the command and monitor lanes of an airplane brake system caused the system to fail (see section 1.6.7 of www.fss.aero/accident-reports/dvdfiles/ES/1998-05-21-ES.pdf)

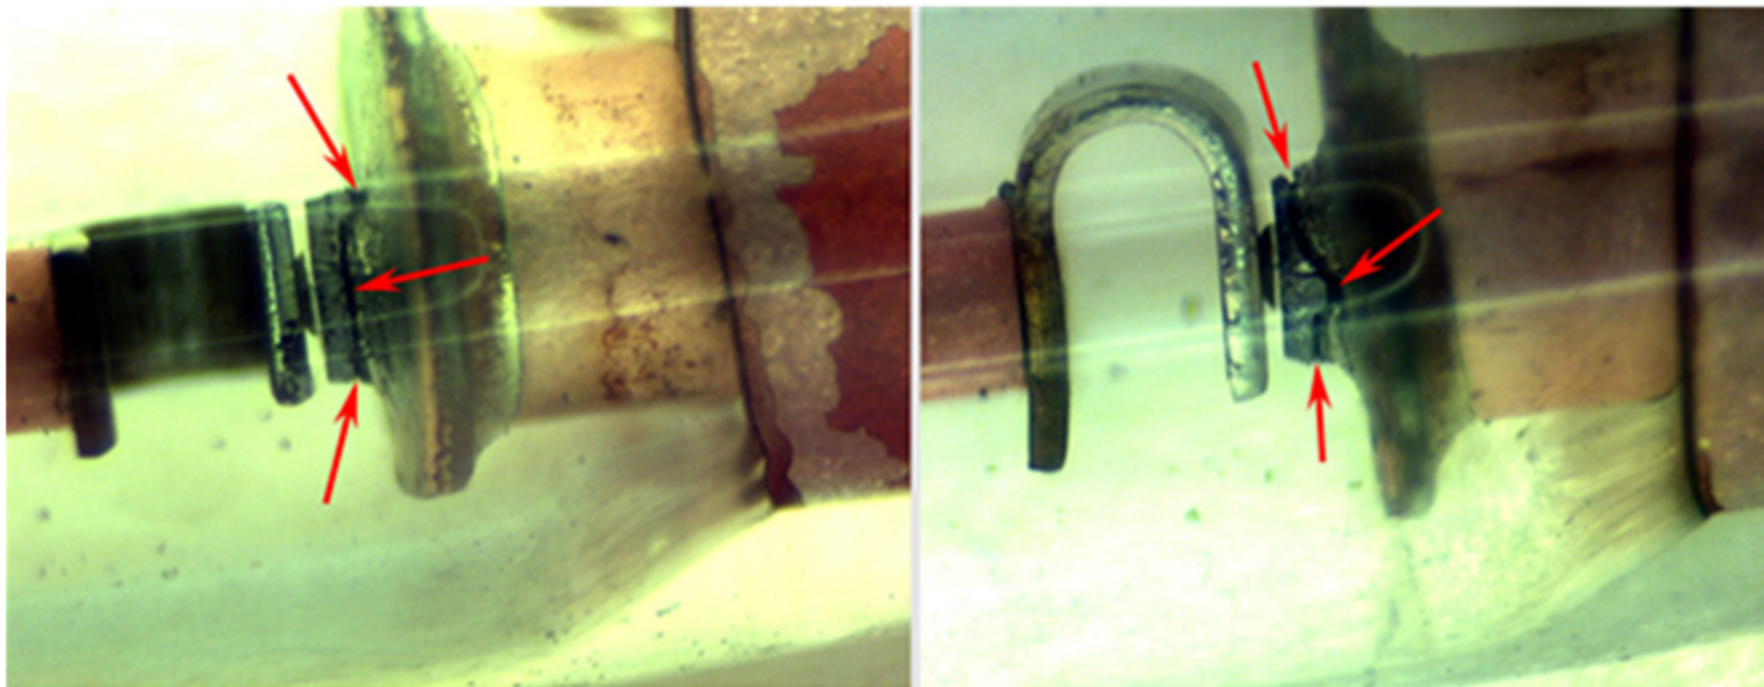
At 12:12 GMT 13 May 2008, a NASA Space Shuttle was loading hypergolic fuel for mission STS-124 when a 3-1 split of its four control computers occurred. Three seconds later, the split became 2-1-1. During troubleshooting, the remaining two computers disagreed (1-1-1-1 split). **Complete system disagreement.** But, none of the computers or their intercommunications were faulty! The **single fault*** was in a box (MDM FA2) that sends messages to the 4 computers via a multi-drop data bus that is similar to the MIL STD 1553 data bus. This fault was a simple crack (fissure) through a diode in the data link interface.

Figure 1. Two views (90 degrees apart) of a fissure that appears to go through the silicon - Red arrows.

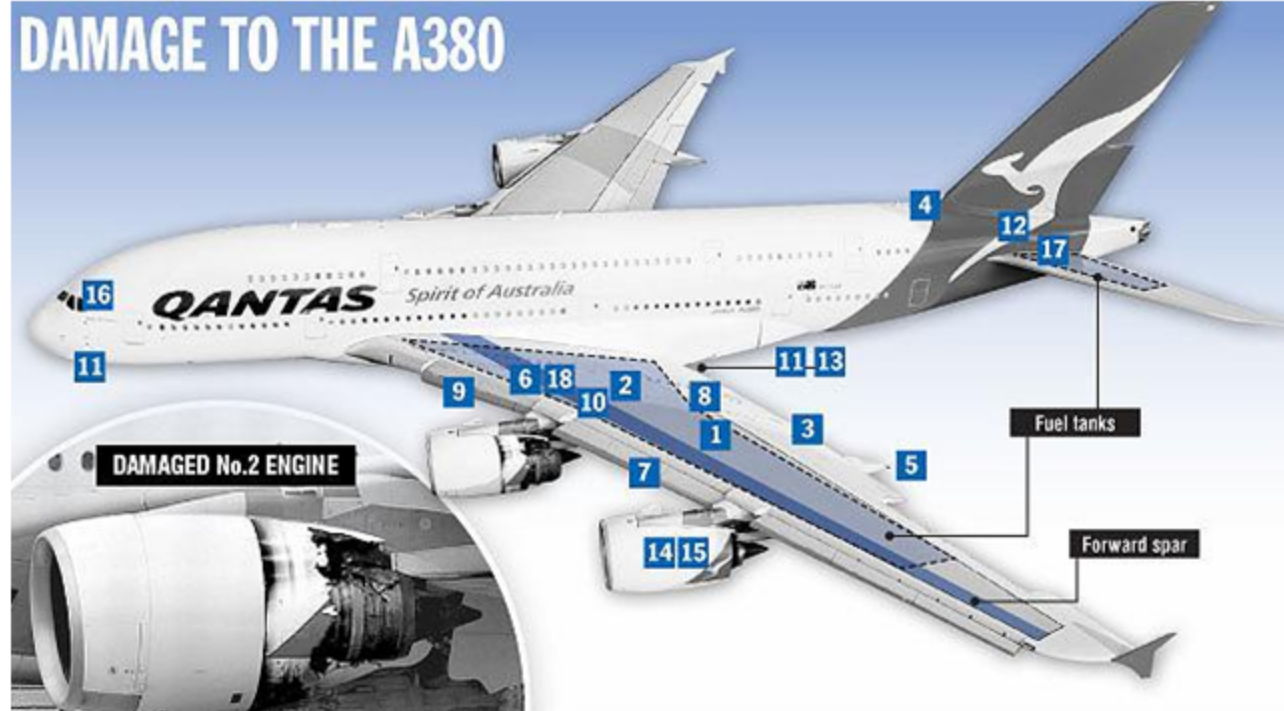
Self-Inflicted Shrapnel, 1st Example

- 1 Massive fuel leak in left mid fuel tank -- there are 11 tanks, including tail's horizontal stabilizer
- 2 Massive fuel leak in the left inner fuel tank
- 3 A hole on the flap fairing big enough to climb through
- 4 Aft fuel system failed, preventing many fuel transfer functions
- 5 Problem jettisoning fuel [180Klbs]
- 6 Massive hole in the top of wing
- 7 Partial failure of leading edge slats
- 8 Partial failure of speed brakes and ground spoilers [and ailerons]
- 9 Shrapnel damage to the flaps
- 10 Loss of all hydraulic fluid in one of the jet's two systems
- 11 Manual extension required for landing gear

12 Loss of one generator and associated systems [electrical busses 1 and 2 failed]

14 No.1 engine could not be shut down in the usual way after landing because of major damage to systems

Only one engine (of 4) was working normally and had thrust reversing. Four blown tires. Leaked fuel on 1600°F wheels.

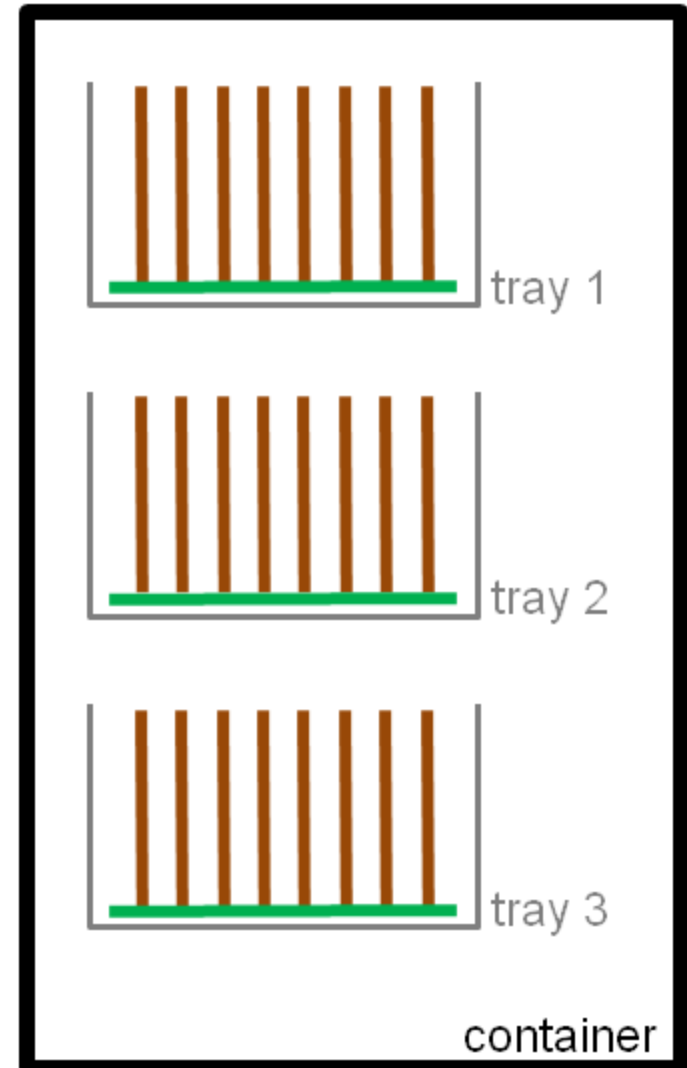
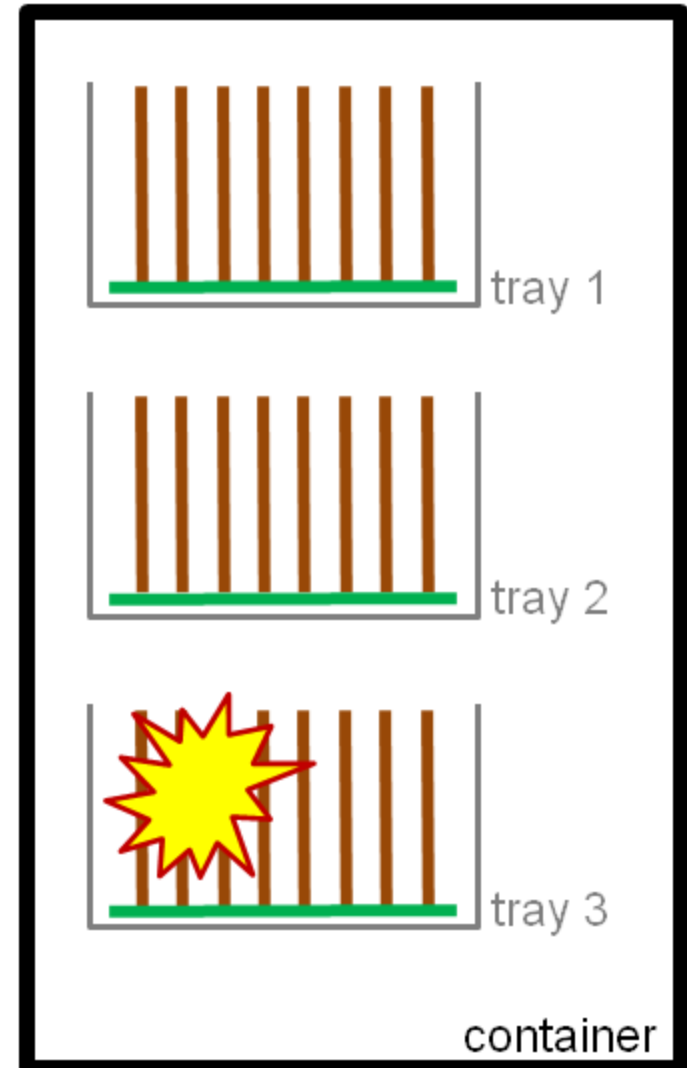
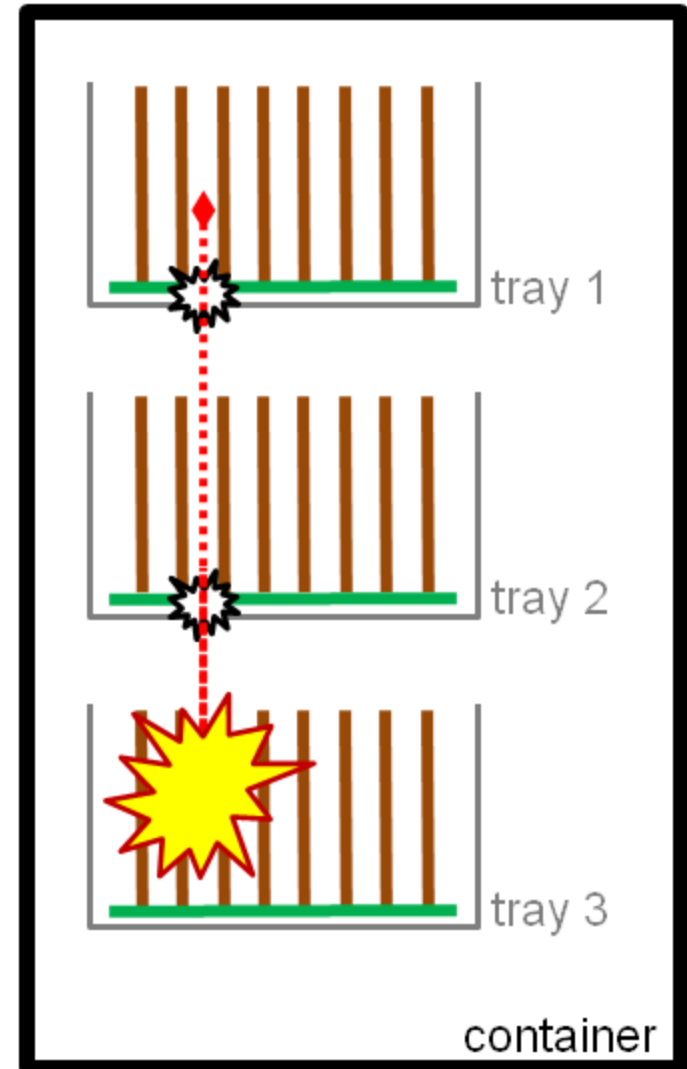
Self-Inflicted Shrapnel, 2nd Example

- Three trays of a redundant military system were enclosed in a single truly “bullet-proof” enclosure. Each aluminum tray had a **horizontal motherboard** and several **vertical printed-circuit cards**.
- A capacitor in the lowest tray exploded, ...

- Three trays of a redundant military system were enclosed in a single truly “bullet-proof” enclosure. Each aluminum tray had a **horizontal motherboard** and several **vertical printed-circuit cards**.
- A capacitor in the lowest tray exploded, sending “shrapnel” (pieces of the thick plastic that had encased the capacitor) **upward** through the other two trays, causing the redundant trays to fail. The “shrapnel” was sharp, shaped like little arrowheads.
- How many failure modes and effects analysis checklists would include self-inflicted shrapnel that could penetrate multiple aluminum trays and motherboards?
- The violence of this explosion was surprising. It shook the walls of the room in which it occurred.
- Having molten pieces from an electrical failure propagate the failure **downward** is generally known (e.g. United B777 P200 panel fire).

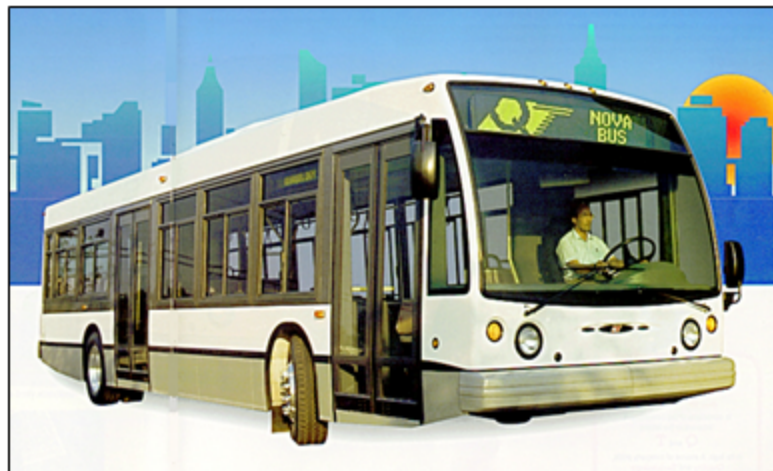
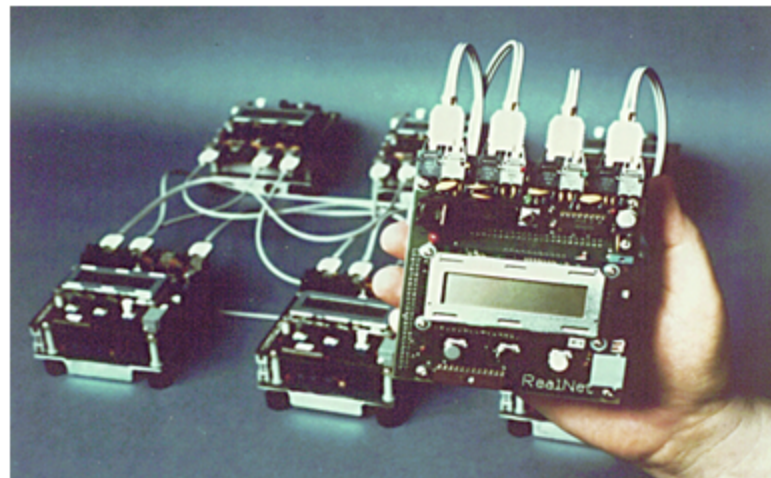
Fiber Optic EMI

- Direct sunlight getting into an open fiber optic cable blinded the FO receiver
 - The system survived because the network’s mesh topology used point-to-point links

- This sunlight infiltration would have been fatal to bus or passive (multi-)star topologies
 - **Another caveat:** FO was used because the 60 MA/s motor inrush currents (di/dt), could cause significant voltage spikes due to $V = L di/dt$, with just tiny inductances. Parasitic capacitive coupling makes transformers not fully effective in blocking these spikes. This is a concern for all “more electric” vehicles (aerospace, ground, and sea) that have high di/dt and can develop inductances in cables, connectors, frame grounds, etc. as they age.

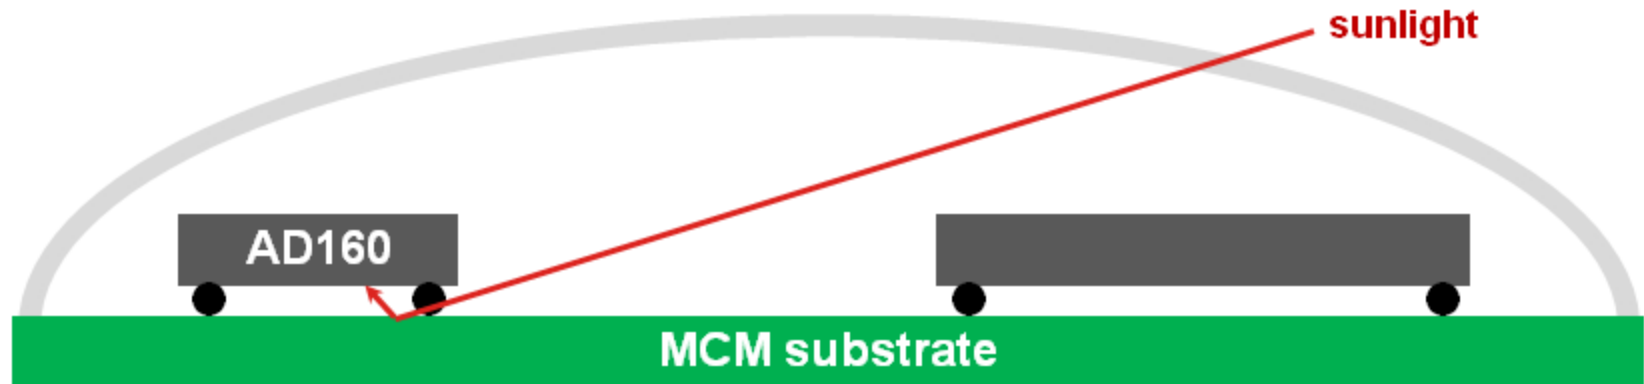
Multi-chip Module (MCM) Die Died?

- A device that used an MCM worked indoors, but not in direct sunlight
- The problem was that ...
 - The dome covering the MCM was slightly translucent
 - Sunlight filtering through the dome was able to get underneath an AD160 integrated circuit die (which was mounted active side down) because of the gap between the die and the MCM substrate due to solder-ball type mounting
 - The sunlight hitting the active surface of the die caused photo currents in the die's active devices, which made it shut down as long as the device was in the presence of sufficiently bright light (even though the AD160 was a power supply IC that shouldn't have been particularly susceptible to photo currents)
- Most semiconductor devices have some susceptibility to photocurrents

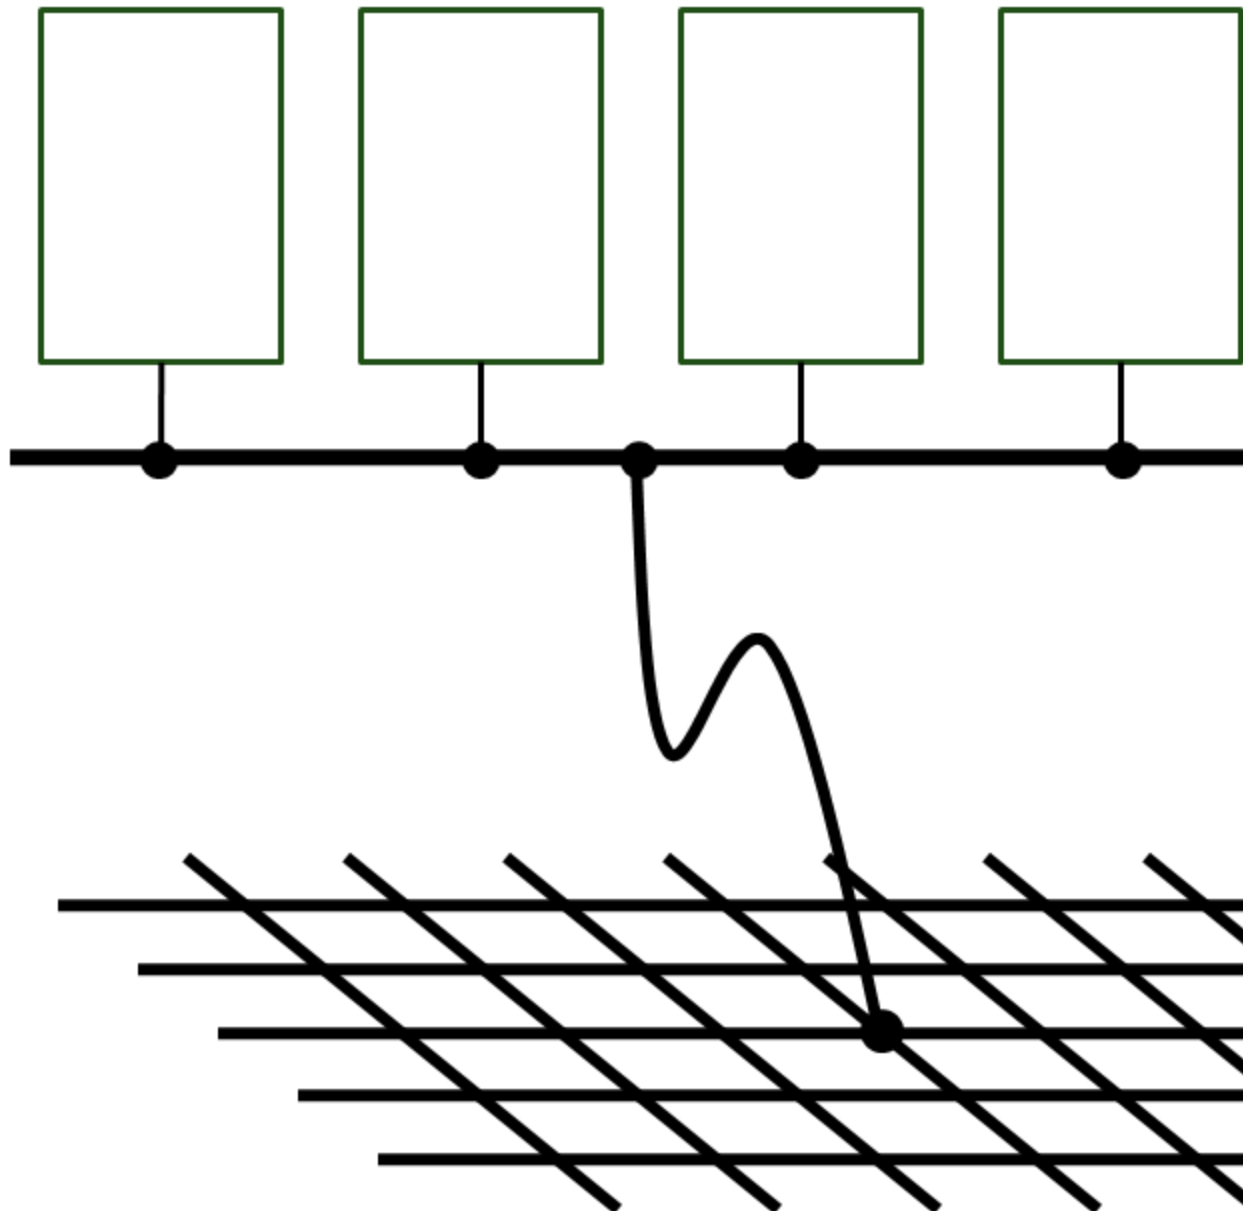
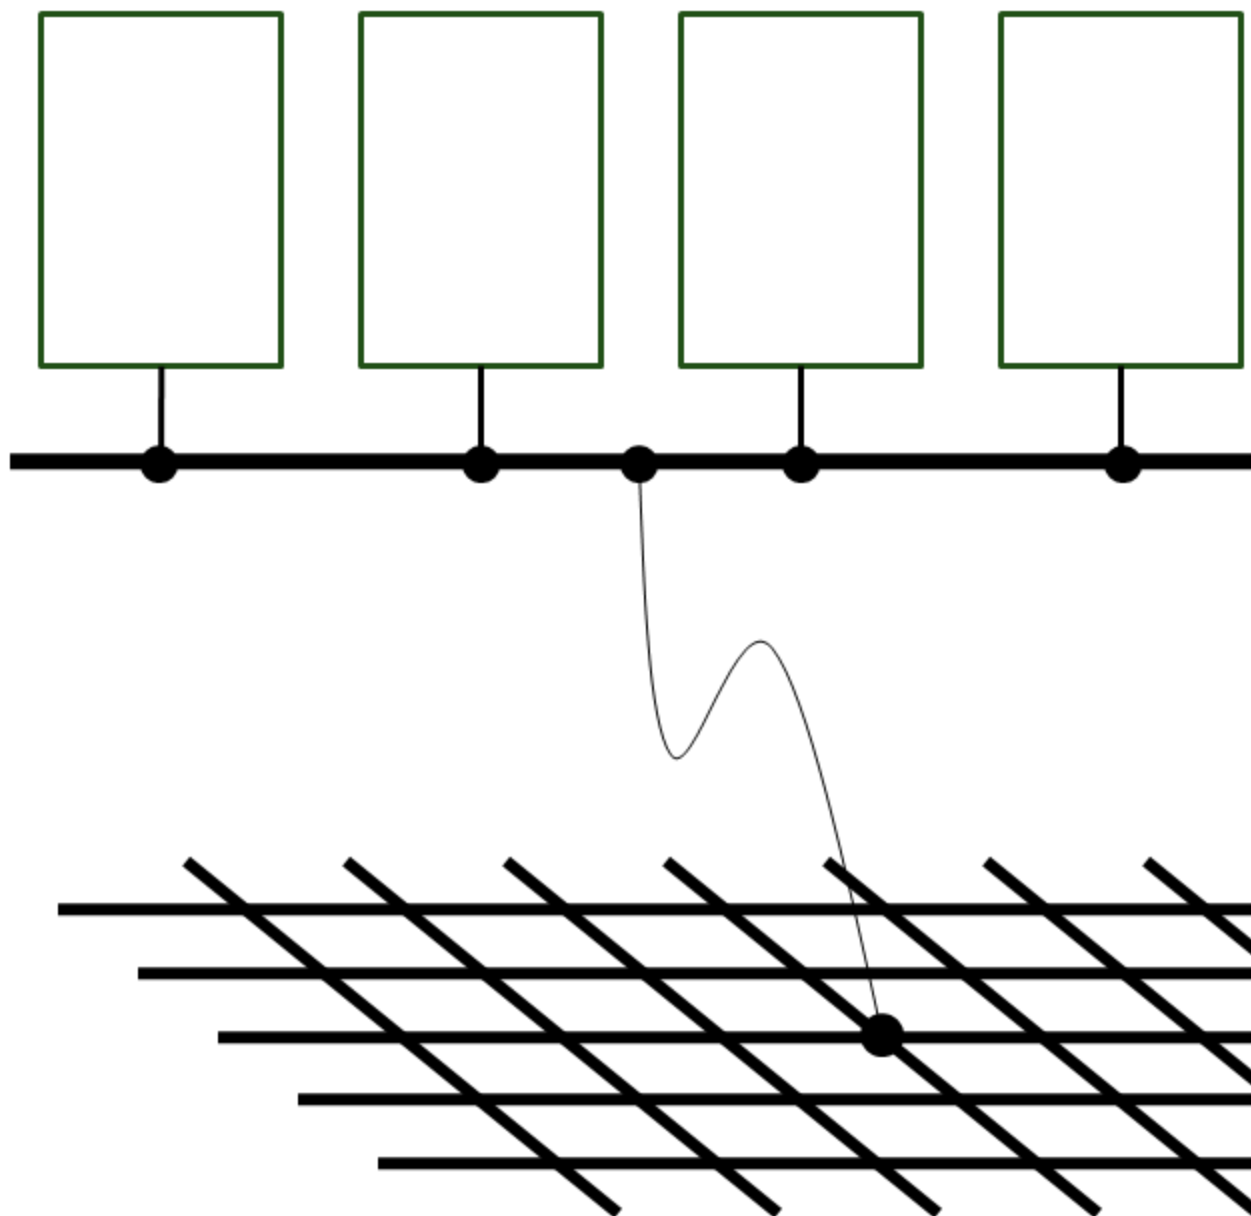
“Sync Bandit”

Multiple relay racks of equipment; each rack dedicated to a comm line. When a rack was reset, it caused the other racks to lose sync; which caused them to reset; which began an indefinitely repeating cycle of resets. The problem was ...

Multiple relay racks of equipment; each rack dedicated to a comm line. When a rack was reset, it caused the other racks to lose sync; which caused them to reset; which began an indefinitely repeating cycle of resets. The problem was corrosion on the cable that connected the racks to the ground mesh under the comm building. Each reset caused a voltage spike across this now high resistance cable; which was amplified by other racks' power supplies and caused them to lose sync.

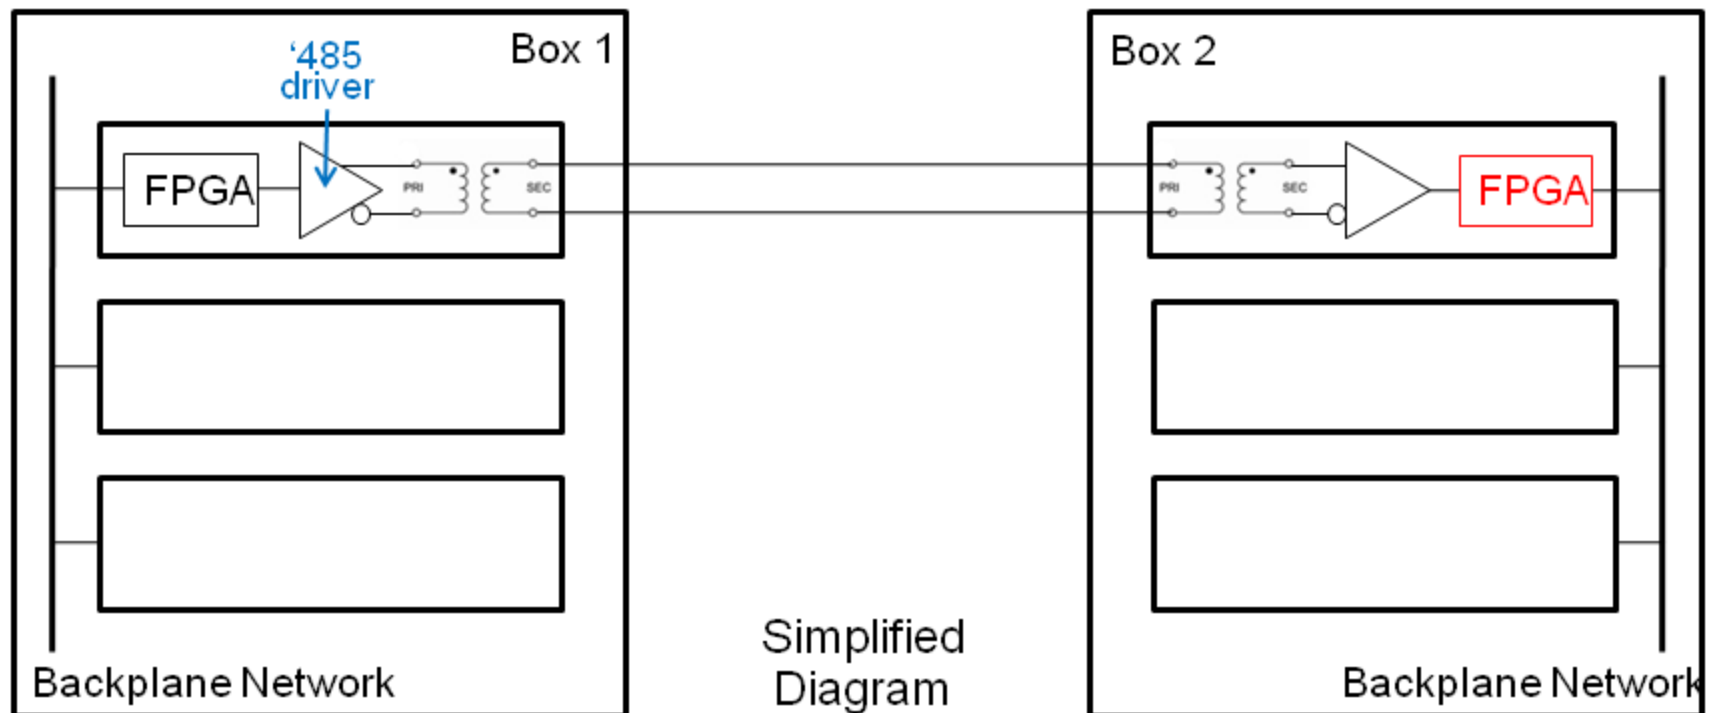
An Oscillatory “Stuck At” Failure

- Our customer naïvely assumed only stuck-at faults (a common assumption) and needed to prevent fault propagation from box to box → the “solution” was to use transformers
- But, due to previous experience and our healthy respect for Murphy, we added an RX **fault-tolerance FPGA** to block arbitrary noise on the inter-box links
- During lab testing, an unconfigured TX FPGA created a stuck-at input to an RS-485 driver
 1. Constant drive into the transformer eventually looked like a short to the driver
 2. This triggered short-circuit protection in driver, which turned off the driver’s output
 3. After 5 ms, short-circuit protection resets, go to step 1
- This converted a stuck-at into a 174 KHz signal that could have killed the second box

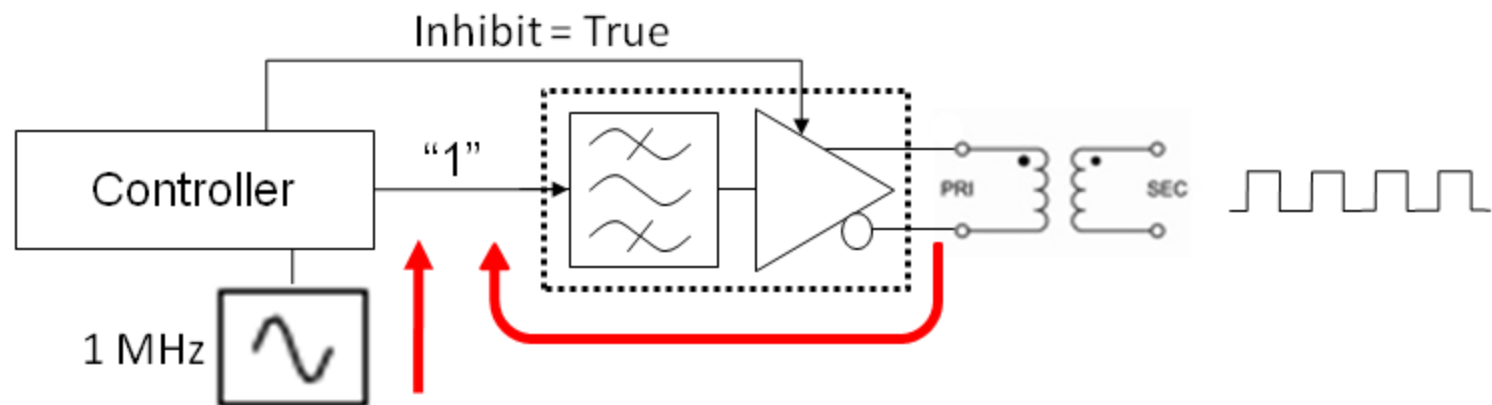
Another Oscillatory “Stuck At” Failure

- A previous incident had a similar symptom, but a different mechanism
- A simple (no internal state) bipolar transistor based MIL STD 1553 bus driver continued to produce a perfectly good Manchester signal (low jitter, period accurate to 50 ppm), even when its output was inhibited and its input was a constant “1”

- The failing driver went into thermal runaway (a common bipolar failure mode)
 - Thermal runaway: increased heat → increased gain → increased current → increased heat

- One obvious result is extremely high gain
- Because of the high gain, the fraction of the output signal that leaked back to the input was amplified until the driver went into oscillation

- The conversion of an amplifier into an oscillator is a very common form of transmutation
- To minimize EMI, the driver included a bandpass filter
 - This kept the oscillation within 1553’s allowed bandwidth (0.5 to 1 MHz)

- The oscillation was further stabilized by noise from a local 1 MHz oscillator
- The result was a very stable 1 MHz square wave on the data bus
- Transmutation sequence: Amplifier → oscillator → phase-locked-loop

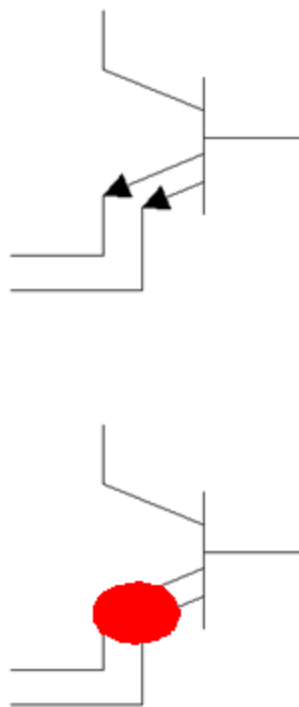
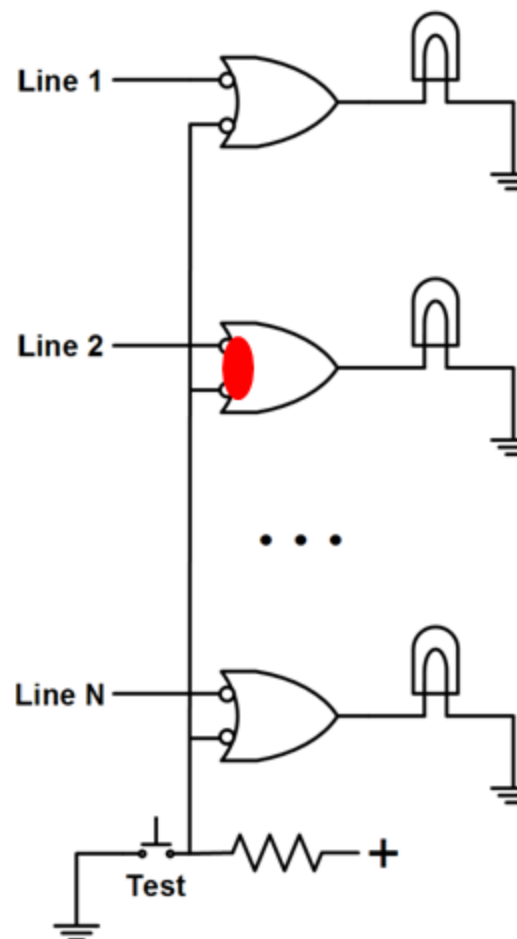
Input → Output, in a Security-Critical Voice Switchboard

Each input of a TTL OR-gate is connected to one of multiple emitters in a single transistor shared among all inputs. A failure shorted the emitters together without other effects to the remainder of the IC. Thus, a signal coming in one input could go out the other input. It is easy to re-create this failure mode (e.g. connect the two wires of an idle phone line to the two inputs).

An active-low signal coming in on Line 2 coupled via the short to the other input of the OR-gate, causing the Test line to go low; which caused all the lights in a secure voice switchboard to turn on. This made it impossible to tell real incoming calls; which were critical at that time.

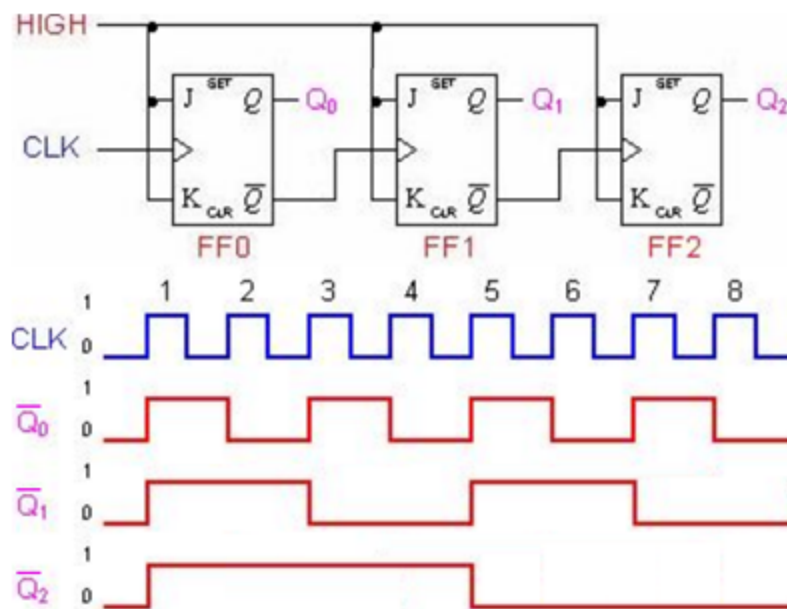
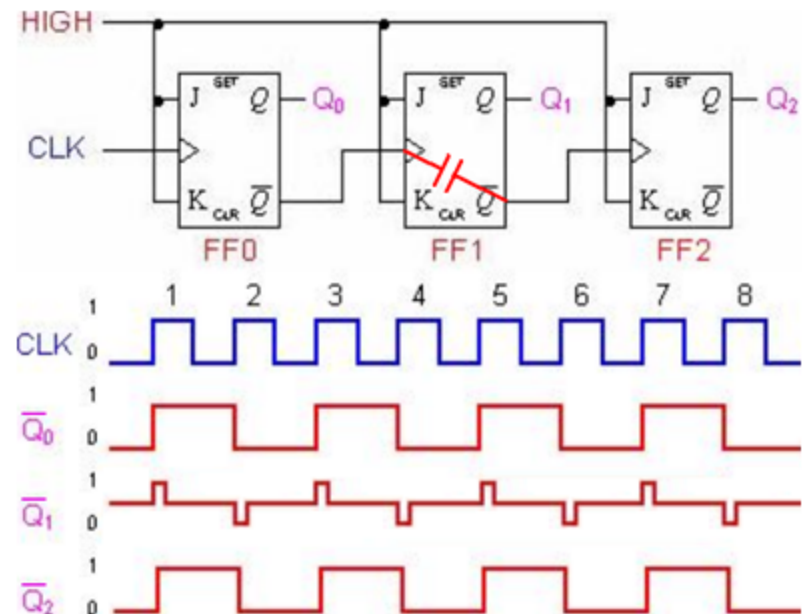
Frequency Divider Becomes Multiplier

- A faulty divide-by-8 counter's output frequency was four times too high
- One of the counter's flip-flops **multiplied its input frequency by 2 instead of dividing it by 2** (good circuit and waveforms shown at left below)
 - The fault caused a capacitive coupling between the bad flip-flop (FF1) clock input (\overline{Q}_0) and its output (\overline{Q}_1). See right-side figure below.
 - The square wave input to the capacitor caused a "doublet" waveform (which is typical for capacitive or inductive coupling) on its output that consisted of two spikes, one for the rising and one for the falling edge of the input
 - The rising edge of each spike caused FF2 to change state

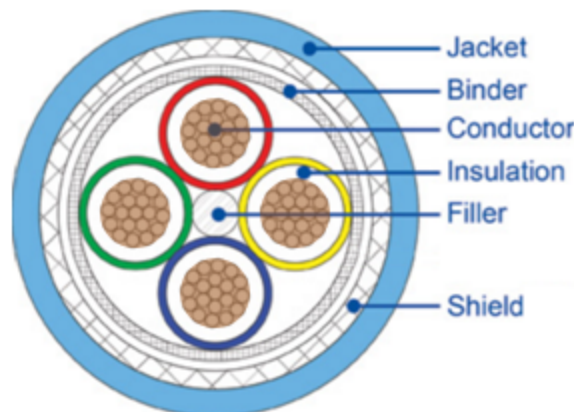
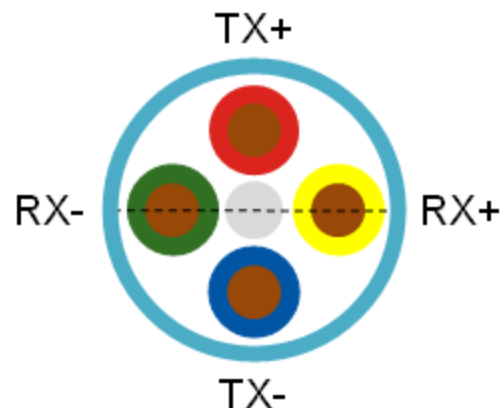
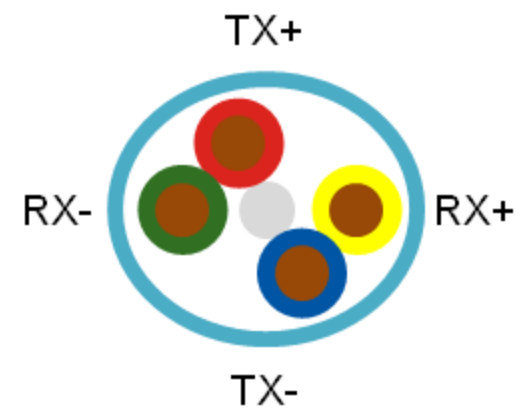
- There were no errors when the cable was uncoiled.
- The 0.5m diameter was much greater than the cable's minimum bend radius of 0.017m.
- The quadrax design requires that the TX and RX pairs be arranged so that the conductors of one pair lie on the plane equidistant from the other pair's conductors, e.g. the RX conductors in the middle figure below are exactly on the plane equidistant between the TX conductors (dashedline). This geometry causes the differential signal in one pair to cancel in the other pair (+ and - signals sum to zero on this plane), preventing TX-to-RX cross-talk.

- The outermost wire of a coil (e.g., the red wire in the third figure below, if the coil axis is below the figure and horizontal side-to-side) travels a greater distance path and the inner wire (e.g. blue) less distance than the other two wires. Because all the wires are the same length, the inner and outer wires get squeezed towards the middle. The greater the number of loops in the coil, the greater the accumulated path length differences and the greater the squeeze (even if the loop diameter stays the same). This distorted geometry couples cross-talk red-to-green and blue-to-yellow, causing interference and a greatly elevated bit error rate.

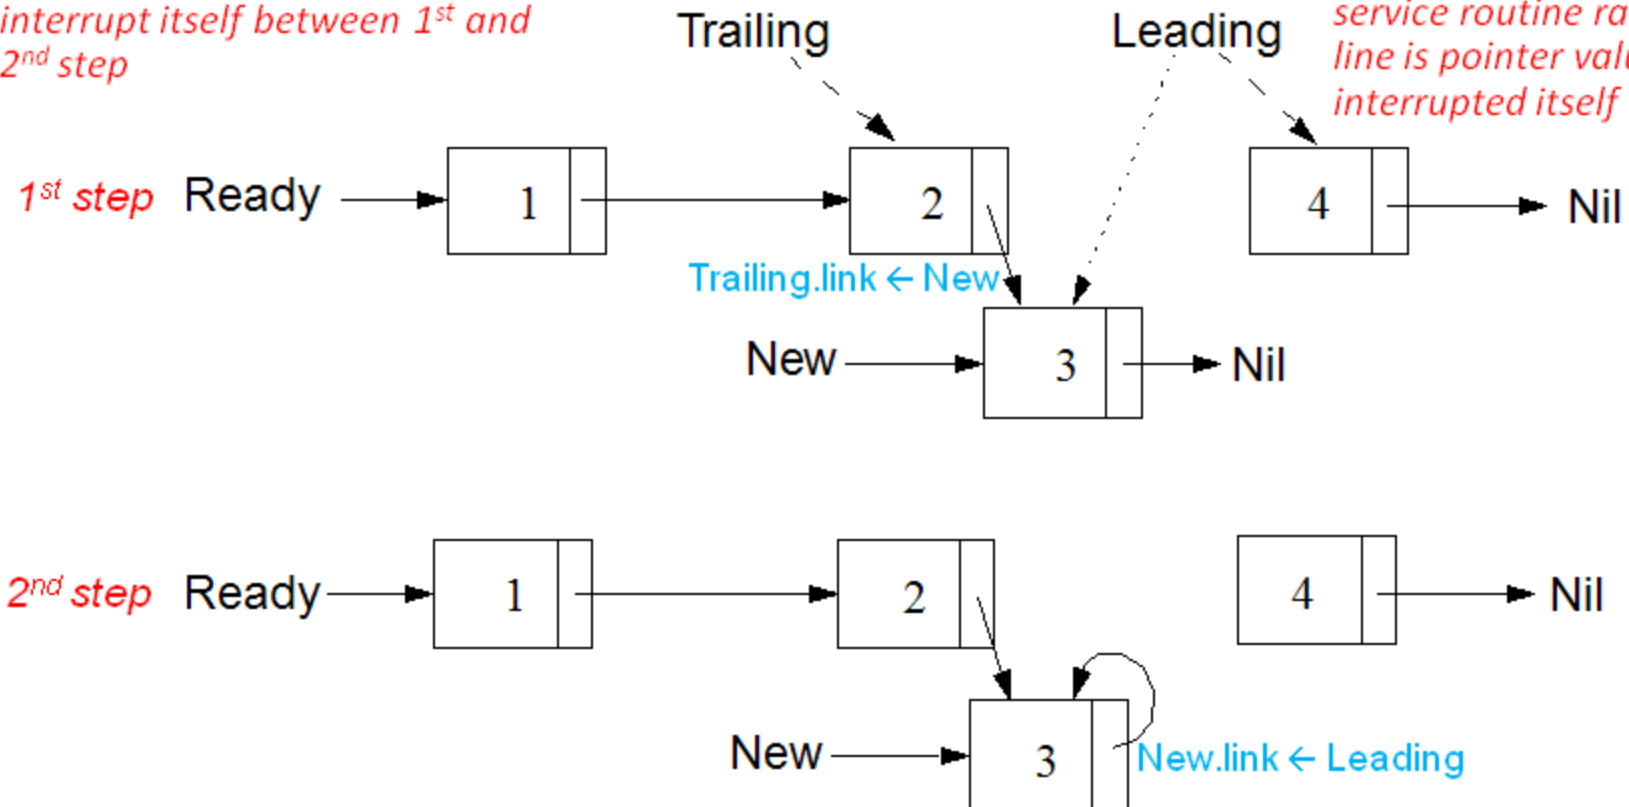
Unsafe and (Very) Unlucky

Interrupt signal "bounce" caused the interrupt service routine to interrupt itself between 1st and 2nd step

The dashed line is pointer value for 1st time interrupt service routine ran, dotted line is pointer value after it interrupted itself

- Linked list search was a single instruction (microcode sequence)
- Having new task control block point to itself caused a microcode infinite loop
- Front panel was "virtual" (polled by microcode); but not polled in the linked list search loop
- This is a "Halt and Catch Fire" data structure
 - Similar to "Halt and Catch Fire" CPU opcodes (see, http://en.wikipedia.org/wiki/Halt_and_Catch_Fire)
- *Can robust partitioning be claimed if a processor can have "Halt and Catch Fire" data structures and/or op-codes?*
