List of Scenarios Outline (1)

- Leading the list are examples of Byzantine failures because of the very widespread “that can’t happen” disbelief in these failures and the fact that there are known solutions
- Introduction to the Byzantine Generals Problem
 - Definitions of Fault, Failure, and Error
 - Byzantine failure definitions and background
- Examples of actual occurrences
 - Space shuttle mission STS-124
 - Space shuttle data bus standing wave
 - Mid-value select
 - Command / Monitor wrap-back
 - Time-Triggered Protocol (TTP/C) heavy ion fault injection
 - Multi-Microprocessor Flight Control System (M²FCS)
 - Potential grounding of an entire aircraft fleet
 - A pushbutton input to the command and monitor lanes of an airplane brake system caused the system to fail (see section 1.6.7 of www.fss.aero/accident-reports/dvdfiles/ES/1998-05-21-ES.pdf)

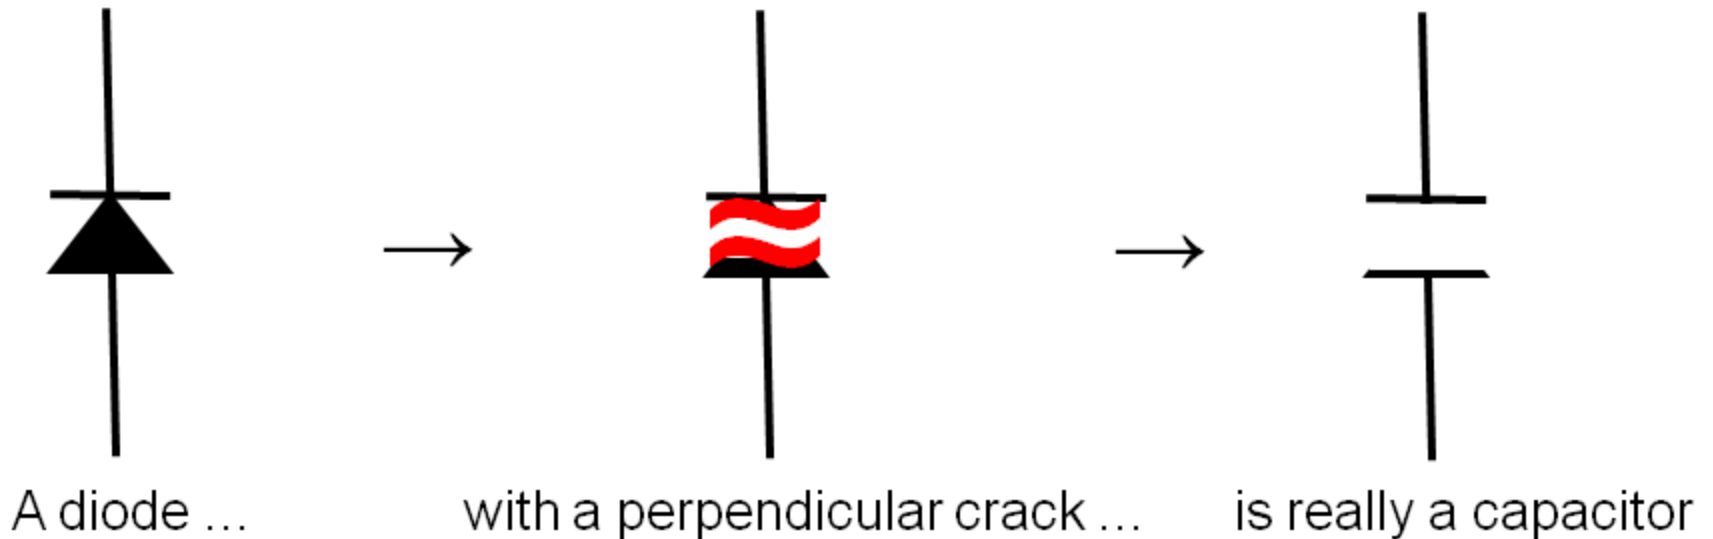
Transmogrification*

How many Failure Modes and Effects Analysis (FMEA) procedures ask what would happen if one electrical part (a diode) changed into another (a capacitor)? At the electrical part level, this appears to be magic. And, yet, the simplest of failures (a crack) caused this transmogrification. The literature includes other examples of capacitors becoming resistors, transistors becoming silicon controlled rectifiers (SCRs), amplifiers becoming oscillators, ...

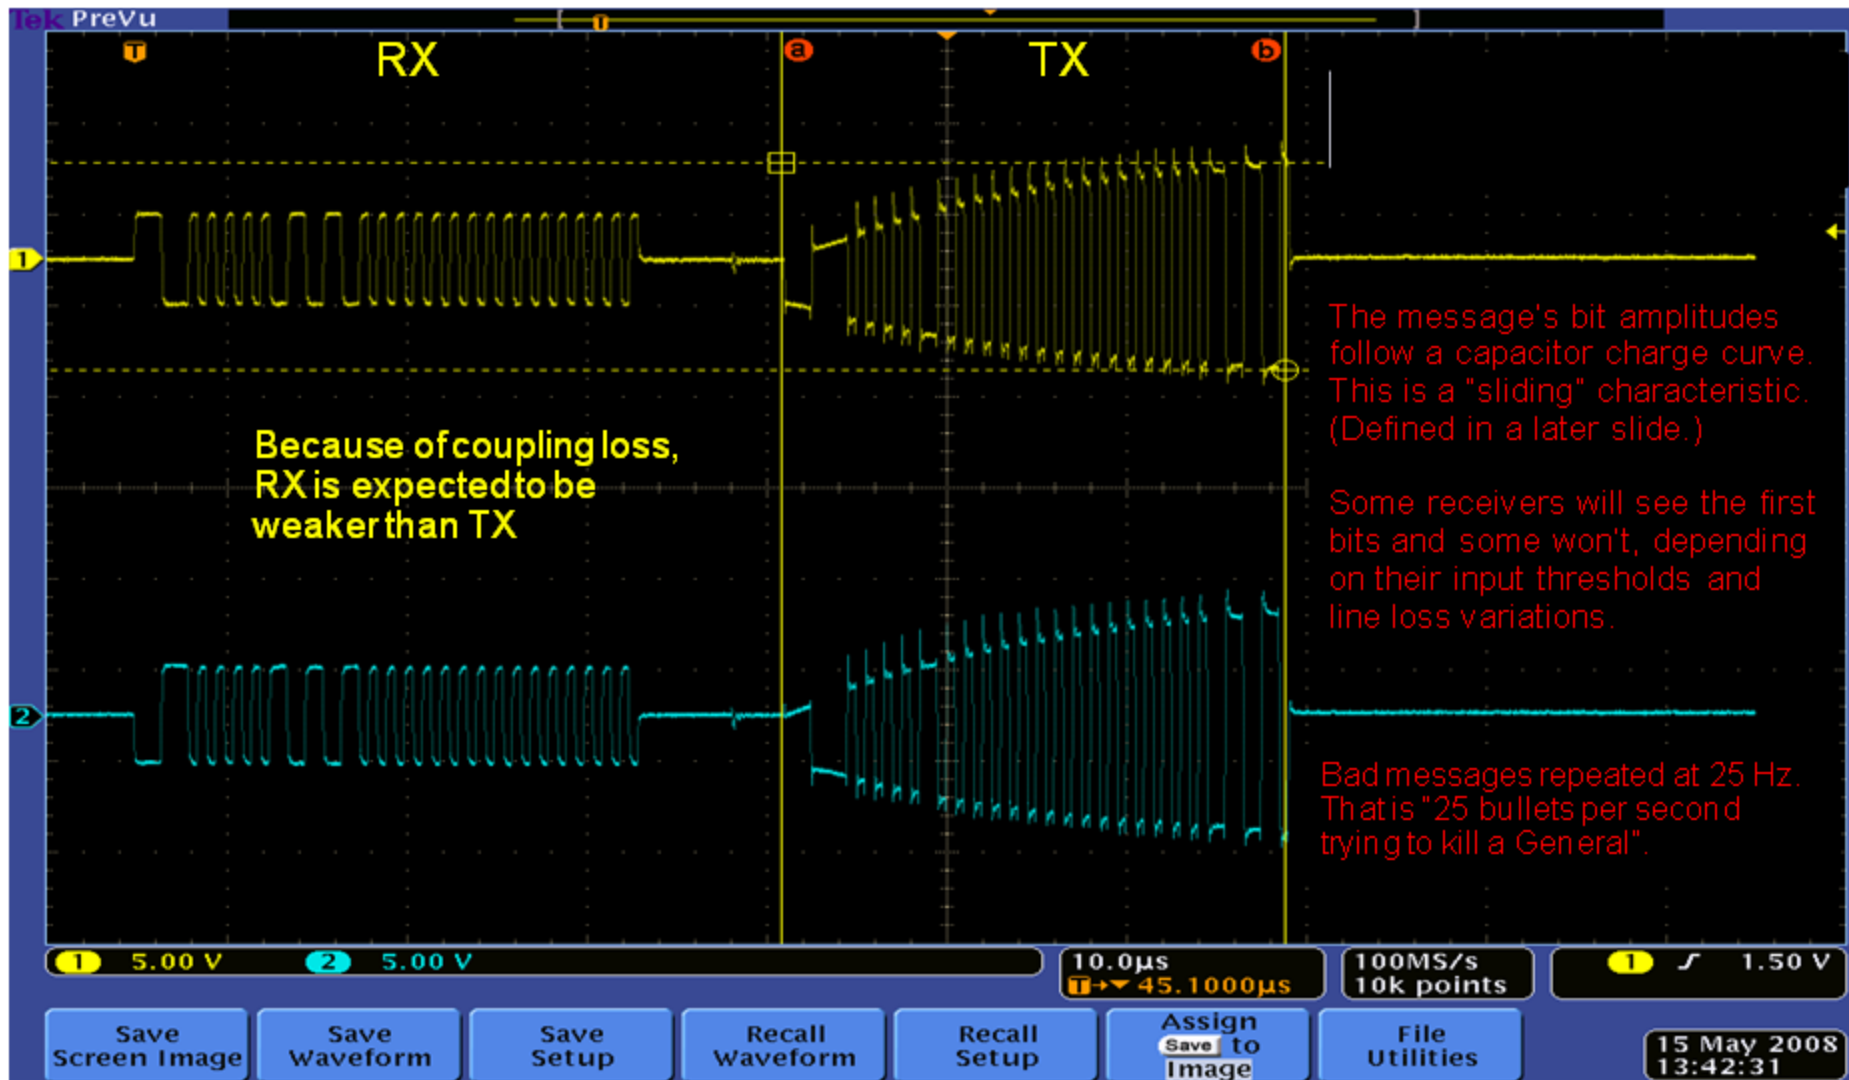
Faulty TX Message on the Right

- This was not the first time a single Byzantine fault on a Shuttle databus has caused the loss of the quad computer system. There have been several of them, with different causes.

- This caused a 2-2 split of the computers. Luckily, this happened in the lab.
- The lesson learned here should not be that diodes or terminating resistors are dangerous, but that Byzantine faults must be tolerated.

- If you think these were hardware problems, you have succumbed to a specialization silo boundary
 - These were software failures in “non-universal error” handling (which “voted out” good processors).

- If this software had been written correctly (to tolerate Byzantine faults), these system failures would not have occurred! The processors would have stayed in agreement.

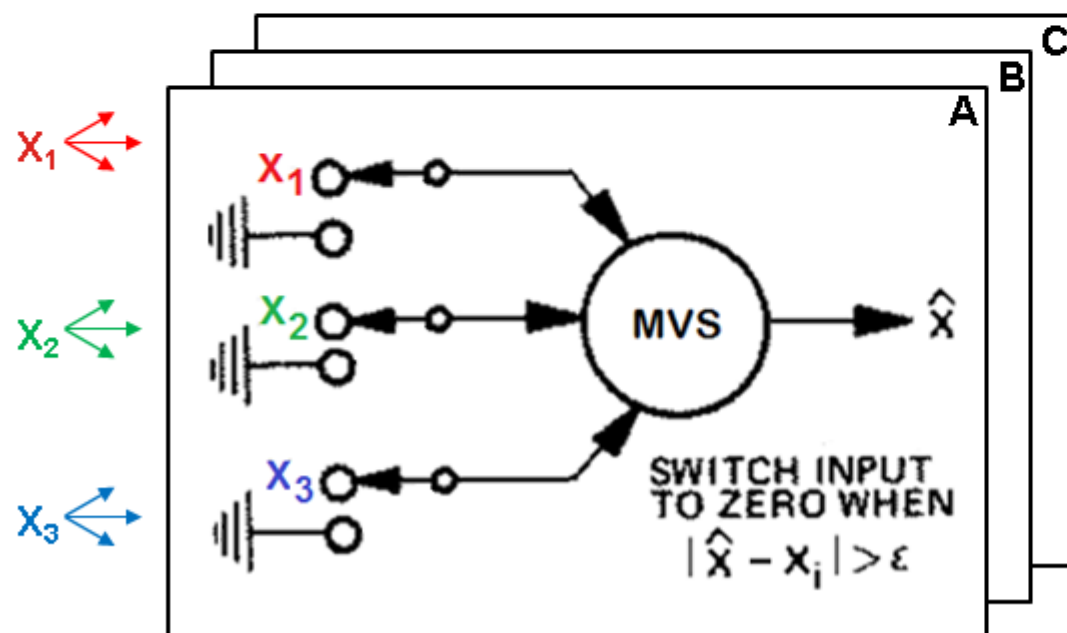
Mid-Value Select (MVS)

- Shows that Byzantine problems are not unique to synchronous or exact-match redundant systems; dispels myths that async and inexact systems are immune
- An example of “if it ain’t broke” fix it until it *is* broke
- Counterproductive attempt to tolerate two faults (a very common design)
 - Any redundant input, X_i , whose value is too much different (ϵ) than the previous MVS value, is assumed to be faulty and forced to be zero (ground), the middle of the valid range
 - The points **A**, **B**, and **C** on the graph show three sampling points of three asynchronous redundant mid-value selectors, named **A**, **B**, and **C** respectively
 - If $X_1 = X_3 + (\epsilon, 2\epsilon]$, it can happen that a persistent state is created in which: the **A** MVS sees X_3 as faulty; the **C** MVS sees X_1 as faulty, and the **B** MVS sees no fault

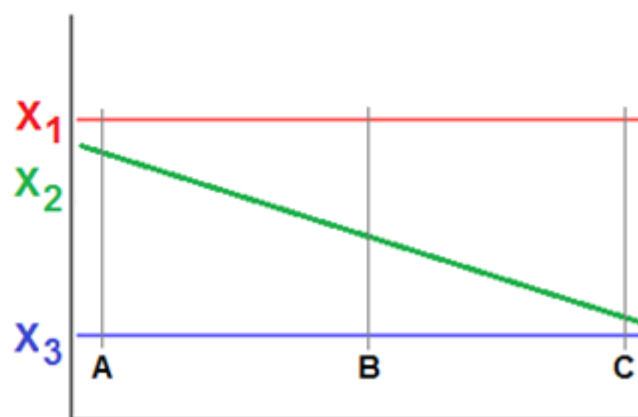
A, **B**, and **C** could see a different \hat{X} after “tolerating” a fault, depending where zero is on this graph.
